AFRL-VA-WP-TR-2003-3088

**INVESTIGATION OF THE EFFECT OF
CORROSION PITTING ON FATIGUE
LIFE OF ALUMINUM STRUCTURE**

Eric J. Tuegel

OCTOBER 2003

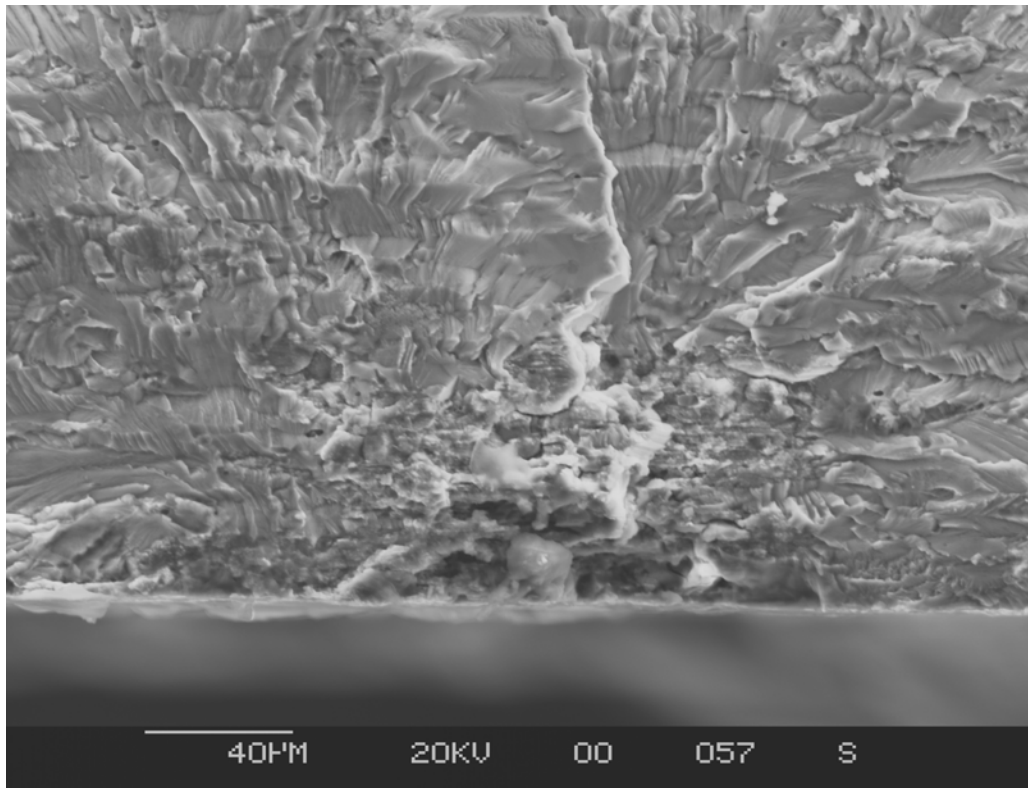
Figure B-99. Crack Origin (A in Fig. B-98) on Specimen 5969.

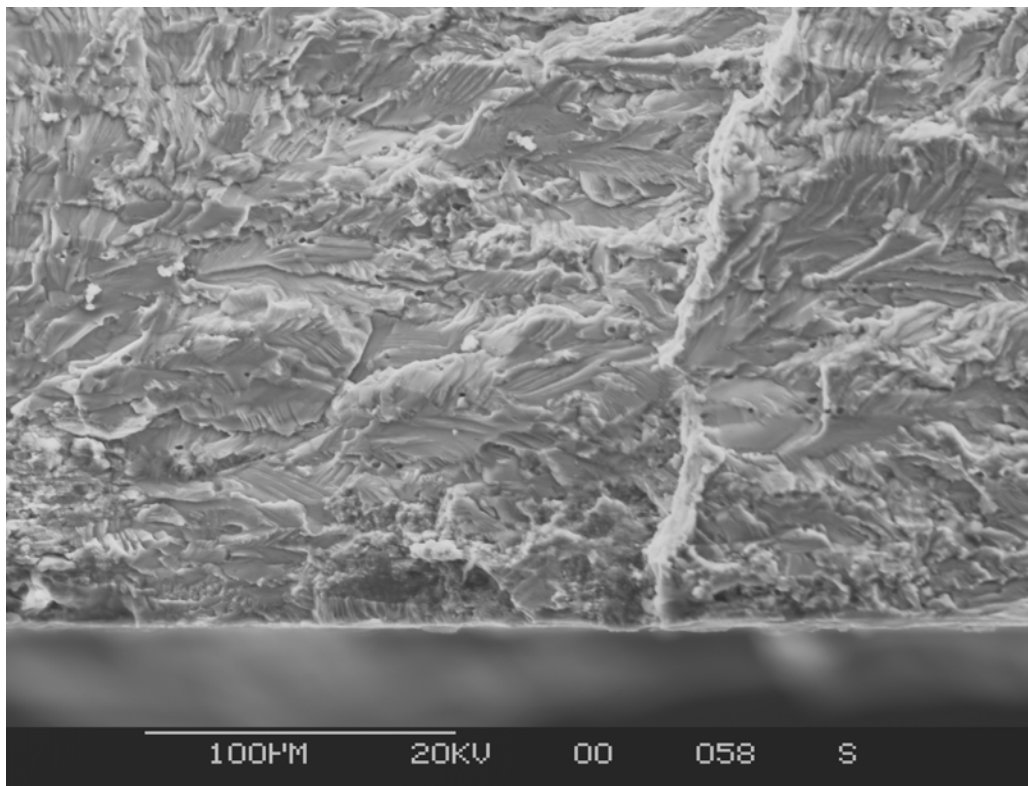
Figure B-100. Pits Adjacent to Crack Origin (B in Fig. B-98) on Specimen 5969.

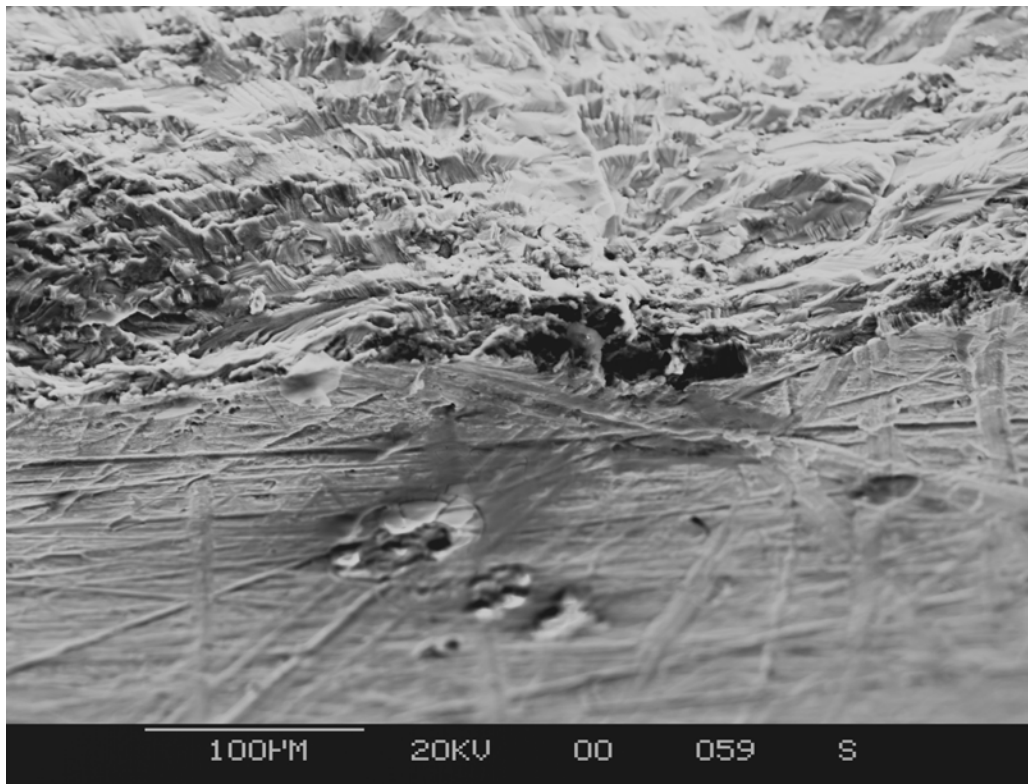
Figure B-101. Surface View of Crack Origin (A in Fig. B-98) on Specimen 5969.

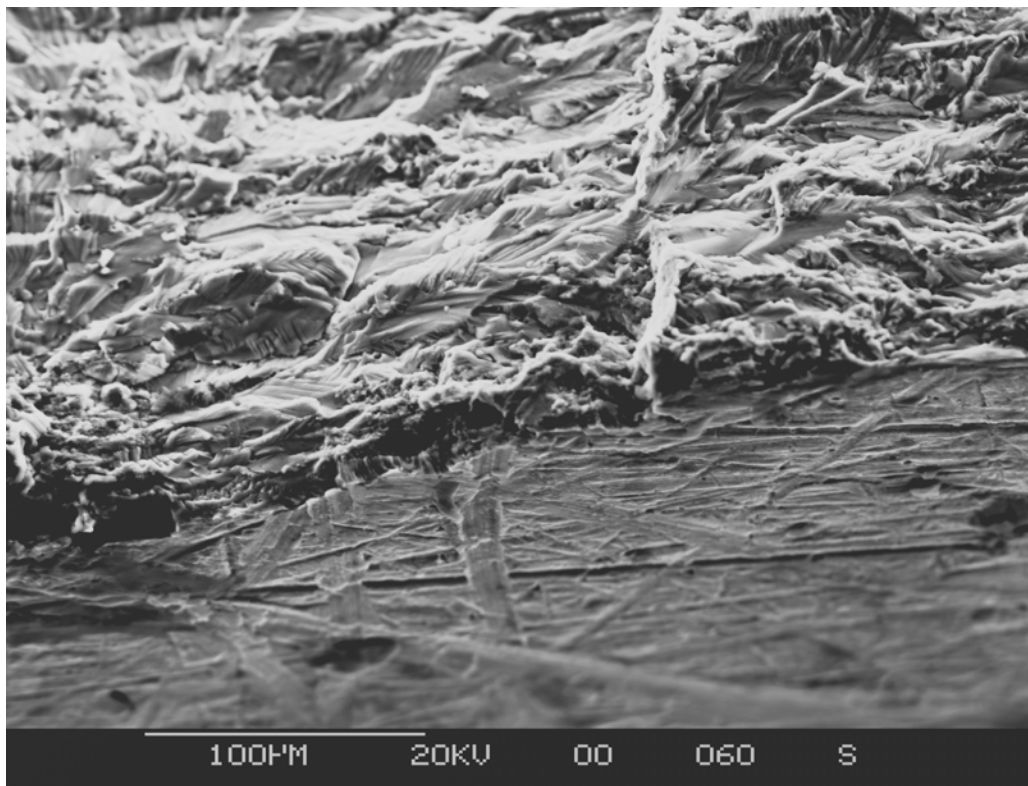
Figure B-102. Surface View of Pits Adjacent to Crack Origin (B in Fig. B-98) on Specimen 5969.

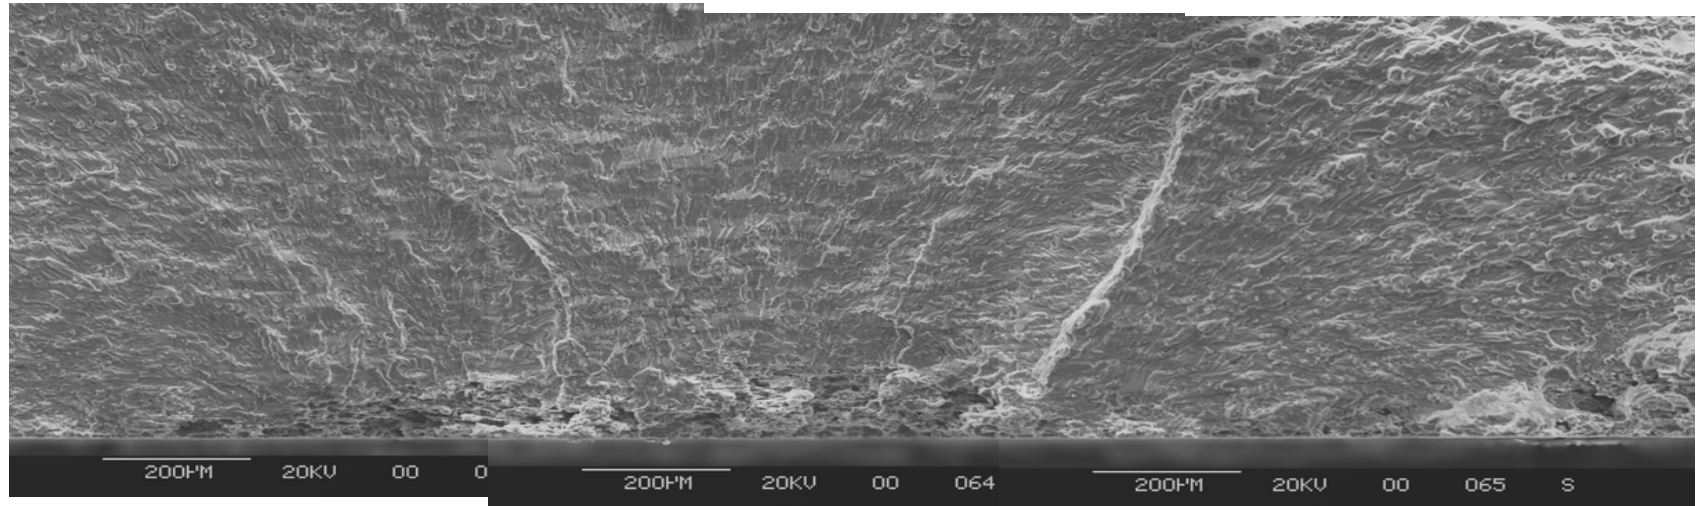
Figure B-104. Composite Photo of Crack Origins on Specimen 6002.

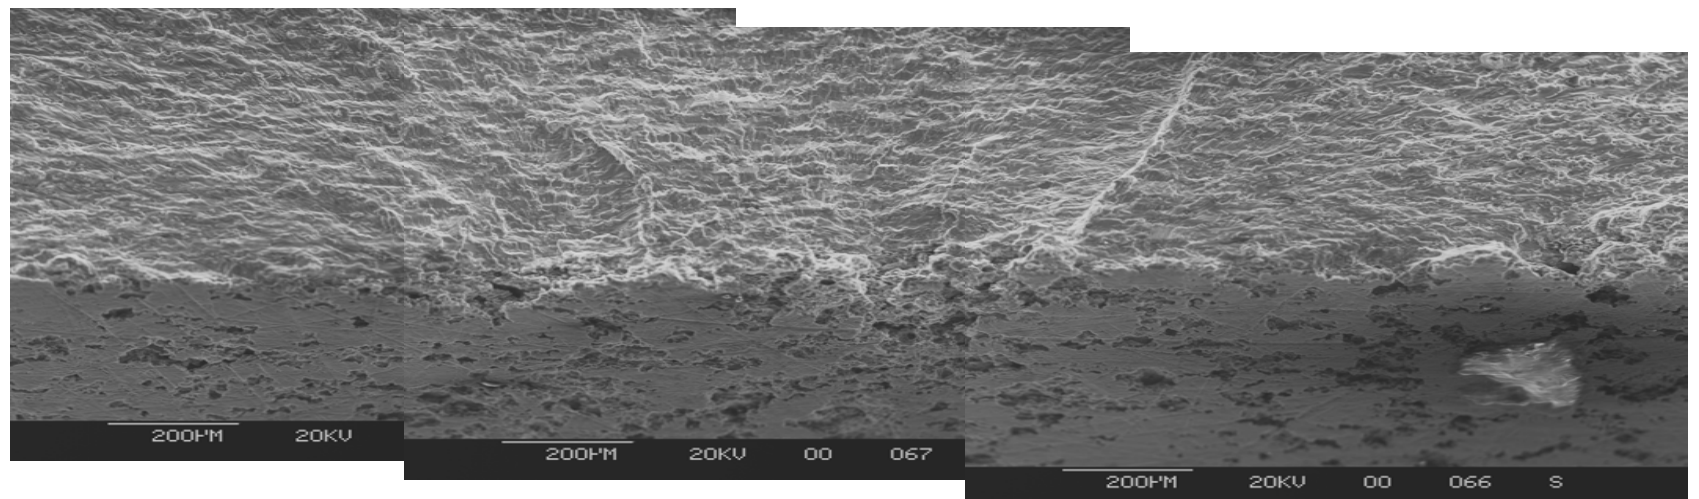
Figure B-105. Edge View of Crack Origins on Specimen 6002.
